AGARDograph No.305 (E)

The Human Factors Relating to Escape and Survival from Helicopters Ditching in Water

Brooks, CJ

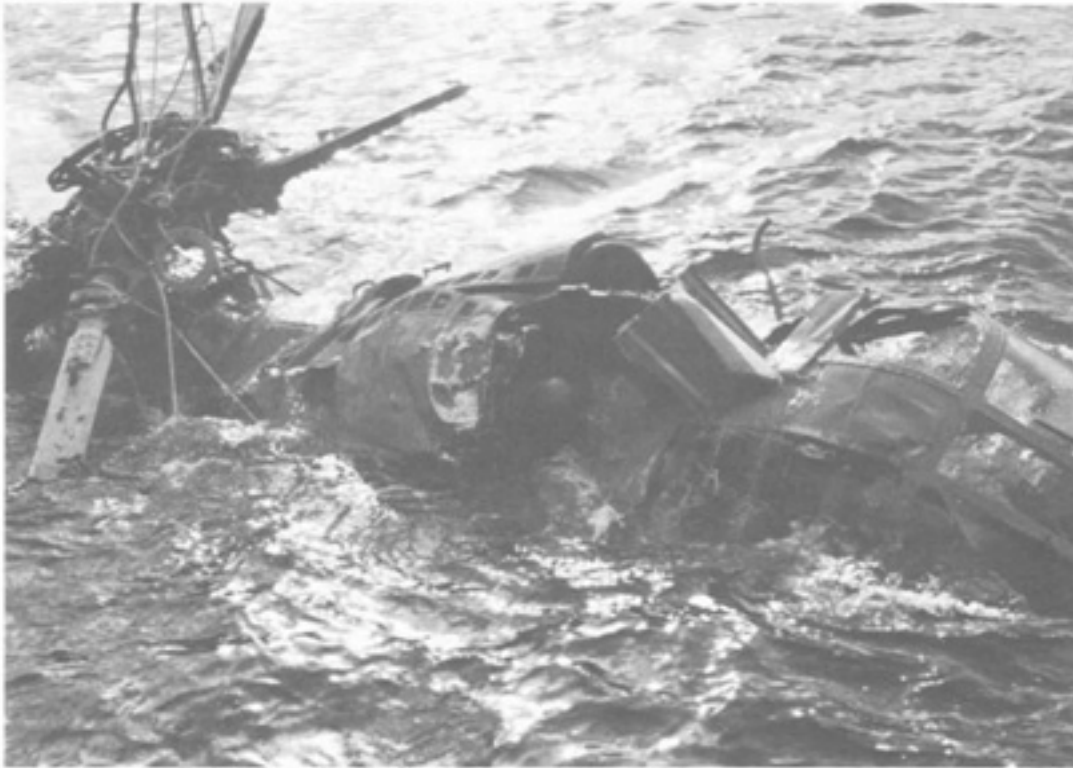
Figure 1. Typical helicopter accident where the helicopter barely floats upright.

The introduction of the helicopter has produced unique problems related to survival after impacts particularly under water escape for aircrew and passengers. Although helicopters tend to be lighter and more buoyant than fixed-winged aircraft, after ditching they either float upright (Figure 1), float inverted (Figure 2) or sink inverted. Unfortunately, unless there is a very calm sea state, the latter two situations occur more frequently and are more likely to result in loss of life. For instance, the Sikorski S61 is designed to stay afloat (if intact) up to conditions of Sea State 3; yet in the North Sea, where it is very commonly used, the sea state exceeds 3 for much of the year.

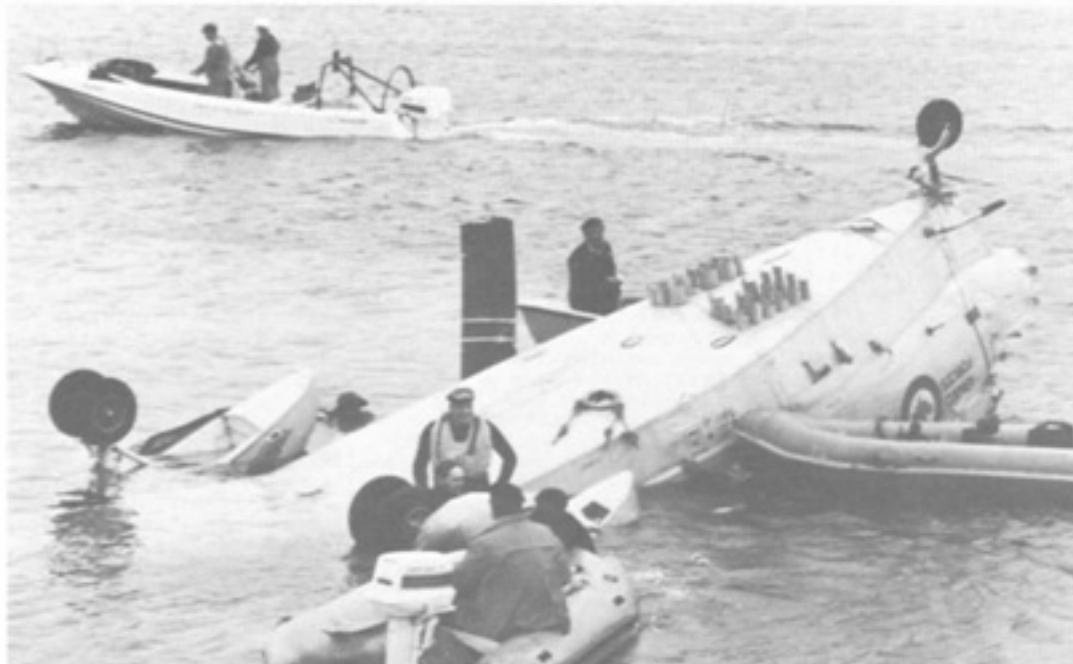
Figure 2. Typical helicopter accident where the helicopter sinks and is rapidly inverted.

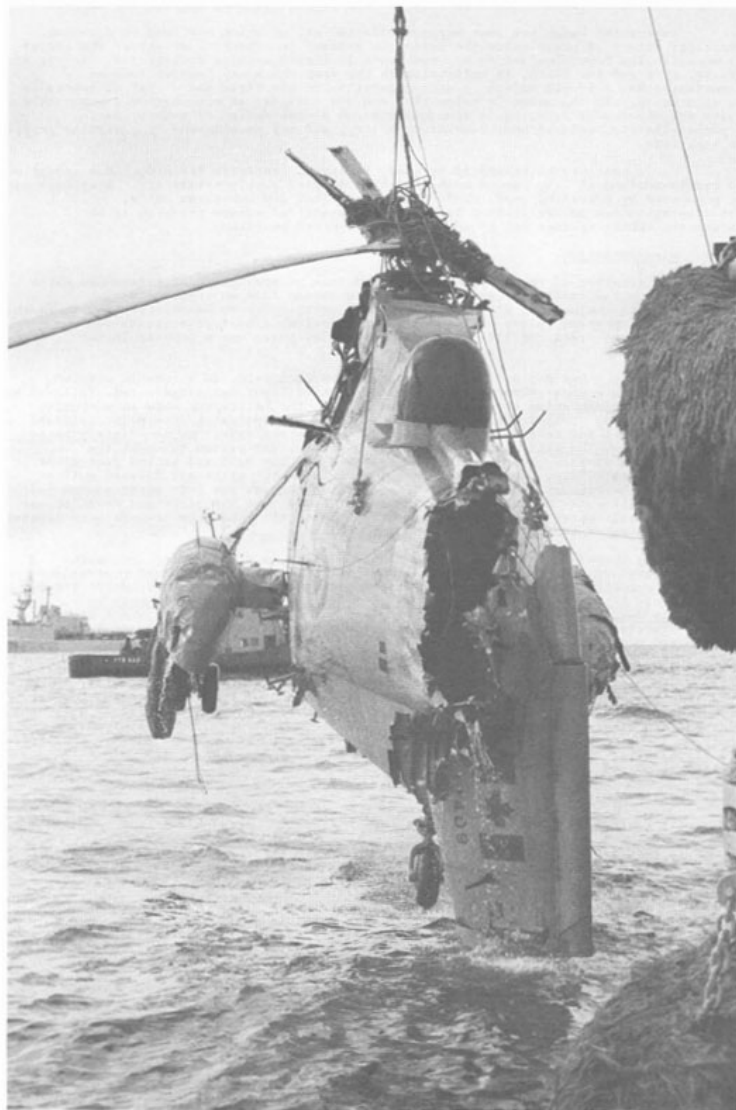
Figure 3. Typical helicopter accident in which cabin has split open on water impact.

This tragic accident clearly points out the necessity for a pre-flight briefing, for the crew and passengers to be aware of the possibility of sudden water immersion due to an in flight emergency during the critical phases of flight, and for all aircrew to be trained for underwater escape. It is also a typical example in which the forces involved in the ditching can literally split open the cabin and throw out the occupants (Figure 3).

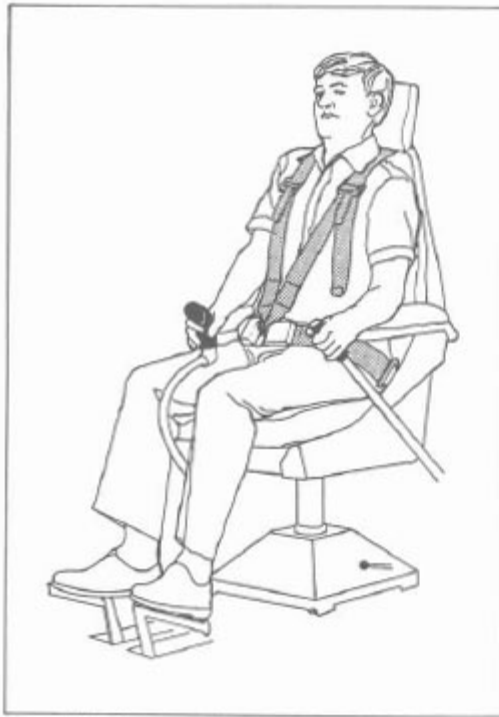
Figure 6. Recommended positions for pilots ditching helicopters in water using a 4 or 5 point restraint harness.

A. Pilot in control - Headrest

(iii) Pilot in Control Headrest Fitted (figure 6A)

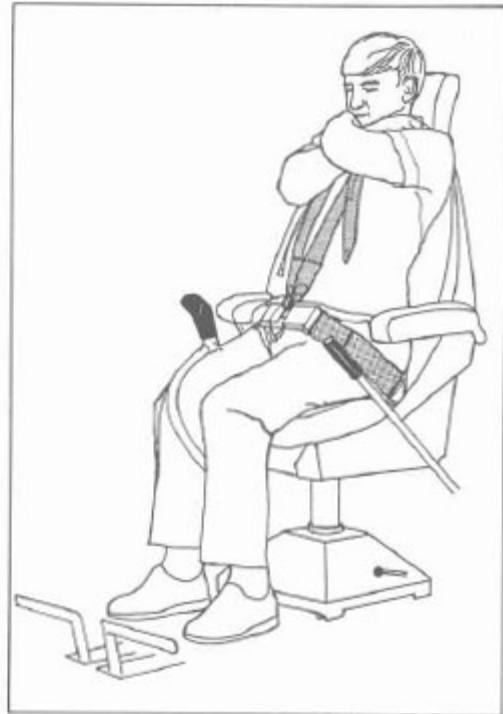
B. Pilot not in control - Headrest

(iv) Pilot in Control Headrest Fitted (figure 6B)

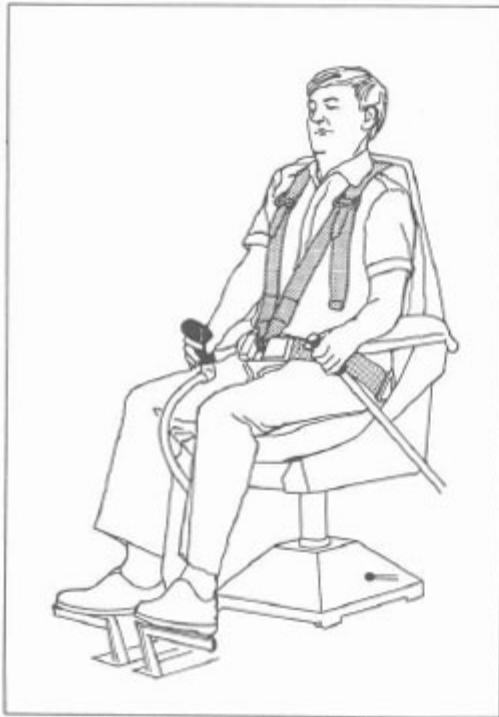
C. Pilot in control - No headrest

(v) Pilot in Control Headrest Fitted (figure 6C)

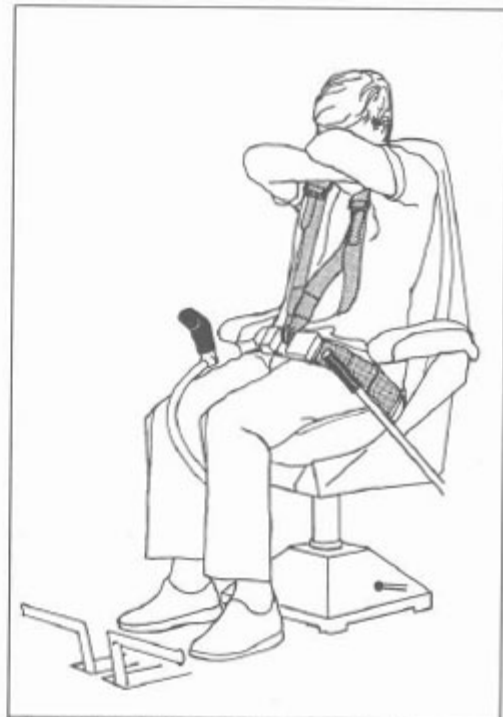
D. Pilot not in control - No headrest

(vi) Pilot in Control Headrest Fitted (figure 6D)

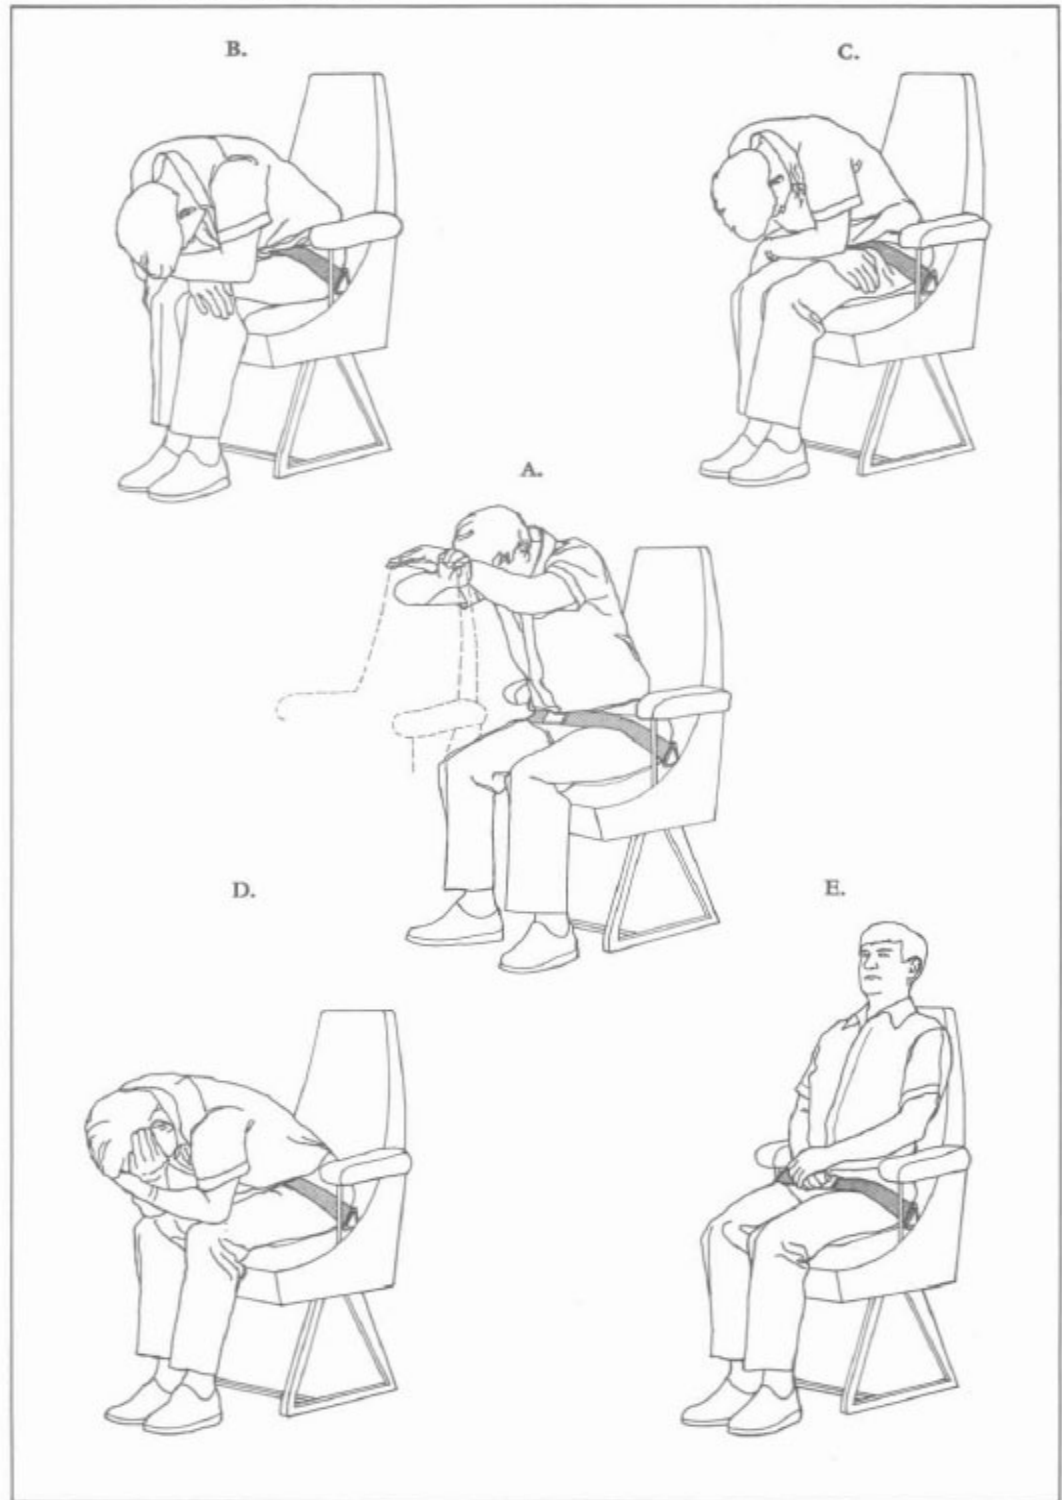
Figure 7. Five crash positions NOT advised for helicopter personnel using lap straps prior to ditching in water.

(vii) Crewmen and Passengers with Lap Strap Only (Figure 7)

This position is the one advocated for rearward facing passengers. The person sits bolt-upright in the seat, buttocks firmly in the back of the seat, head pushed into the back of the seat, knees together, heels together and feet pressed firmly on the floor. The hands are held together in front of the pubic bone (Figure 7E). This position assumes that the majority of the force exerted on the passenger will be forward, whereas it is more likely to be vertical. This again is a poor position for under such conditions there is no protection for the face and the body presents a large strike area and will likely jack-knife on to the knees of the passenger in the facing seat. Resulting spinal, cranial and facial injuries could be fatal. It is an unstable position.

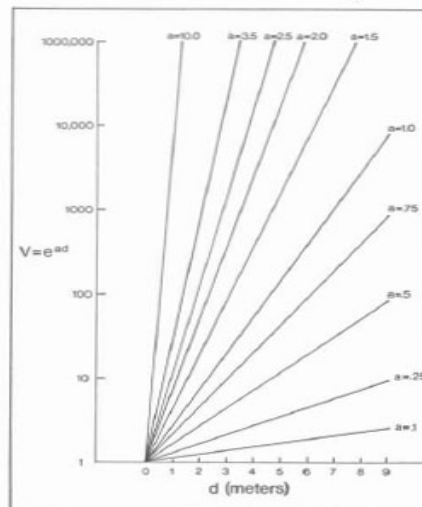
Figure 11. Nomograms for estimating the threshold luminance of a light in the water for an observer without a facemask.

v = degree of transmittance of the light through the water
 d = distance the light must travel to the observer
 a = turbidity of the water (an "a" of 0.1 indicates very pure water, whereas an "a" of 3.0 is characteristic of turbid harbour water).
 (Courtesy Smith & Luria, USN Submarine Research Laboratory).

Optical characteristics of the lights were then studied by a team at Groton (68). They stated that the visibility of a light underwater depends primarily on intensity, viewing distance, water turbidity and dark adaptation of the observer. Nomo grams were established for estimating the threshold luminance of a light in the water for an observer without a facemask (Figure 11).
